December 2017

Subject: Pacemakers – Technical programming information on Minute Ventilation Sensor.

Ref.: 92186345-FA

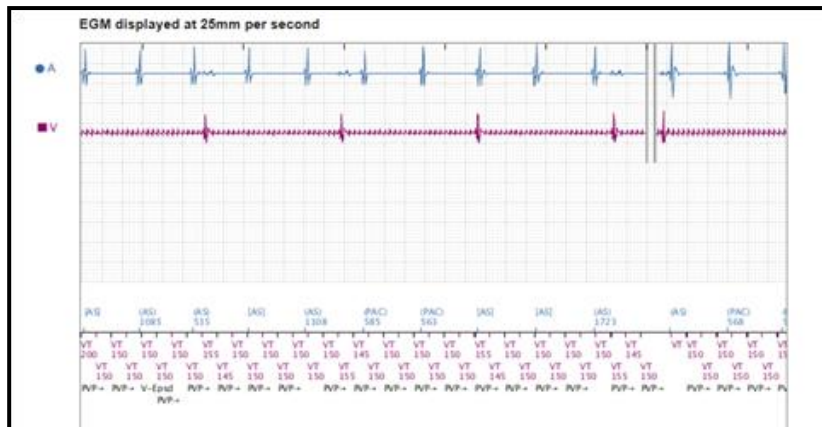
Figure 2. Example of MV signal oversensing

Boston Scientific pacemakers perform an MV lead check approximately every hour to assess lead and lead connection integrity. The active vector may be the primary vector (distal RA ring electrode to the pacemaker case) or secondary vector (distal RV ring electrode to the pacemaker case). Since either vector may be used to measure MV, at least one of the implanted leads must have normal bipolar lead impedances. Typically the MV sensor signal is appropriately filtered out by the pacemaker. However, if a high impedance condition is detected within the lead-pacemaker system, the MV sensor signal may be oversensed (Figure 2).

- For pacemaker-dependent patients, turn the MV sensor “OFF”. Note when programmed to passive, the MV sensor signal is enabled and may be oversensed. See Appendix B for details on turning the MV sensor “OFF”.

- In accordance with the pacemaker manual, if MV sensor signal artifacts are observed on EGMs and leads are performing appropriately, consider programming the sensor to “OFF” to prevent oversensing.
